DEPARTMENT OF TRANSPORTATION

Contract #: 04-0120F4Cty: SF/ALA Rte: 80 PM: 13.2/13.9File #: 1.28**WELDING INSPECTION REPORT****Resident Engineer:** Casey, William**Address:** 333 Burma Road**City:** Oakland, CA 94607**Report No:** WIR-028840**Date Inspected:** 01-Dec-2012**Project Name:** SAS Superstructure**OSM Arrival Time:** 700**Prime Contractor:** American Bridge/Fluor Enterprises, a JV**OSM Departure Time:** 1530**Contractor:** American Bridge/Fluor Enterprises, a JV**Location:** Job Site**CWI Name:** As noted below.**CWI Present:** Yes No**Inspected CWI report:** Yes No N/A**Rod Oven in Use:** Yes No N/A**Electrode to specification:** Yes No N/A**Weld Procedures Followed:** Yes No N/A**Qualified Welders:** Yes No N/A**Verified Joint Fit-up:** Yes No N/A**Approved Drawings:** Yes No N/A**Approved WPS:** Yes No N/A**Delayed / Cancelled:** Yes No N/A**Bridge No:** 34-0006**Component:** Tower**Summary of Items Observed:**

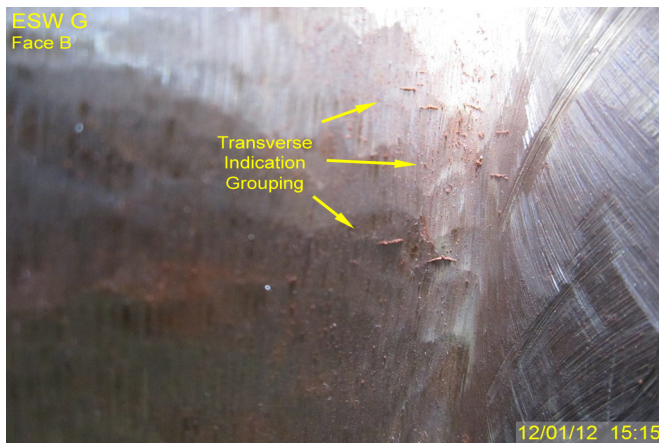
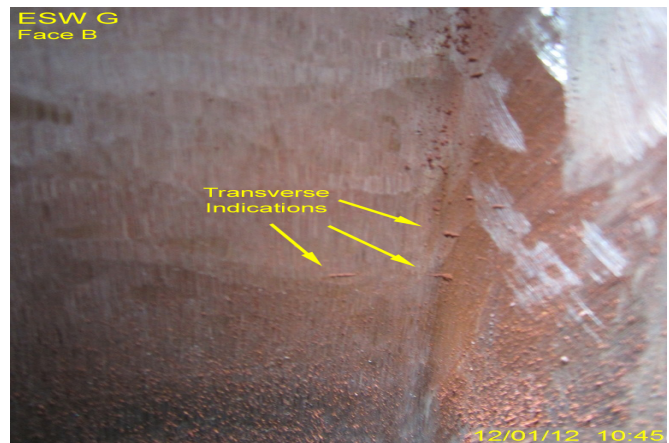
This QA performed observation of excavation of Electroslag Weld (ESW) designated as ESW G. Excavation was performed at location (Y= 7180mm~7400mm).

Y= 7218mm (Transverse Indication)

Y= 7175mm~7215mm

Approximately eight (8) Transverse Indications (random placement)

Excavation has been halted at end of shift.

Excavation was performed by ABF personnel Reginald Humphrey using a mechanical grinder removing approximately 1mm at a time. This QA observed Quality Control Inspector Andrew Keech performing visual inspection and Magnetic Particle Testing (MT) of this excavation between passes. This QA performed visual inspection and intermittent verification MT of this excavation between passes.
